RE: *Environmental Investigation Results*
Former Rehabilitation Center Property at West Virginia State University
Institute, West Virginia

East Property Boundary Investigation at West Virginia State University, Bayer CropScience Institute Facility, Institute, West Virginia

PREPARED FOR: Union Carbide Corporation (UCC)

PREPARED BY: CH2M HILL

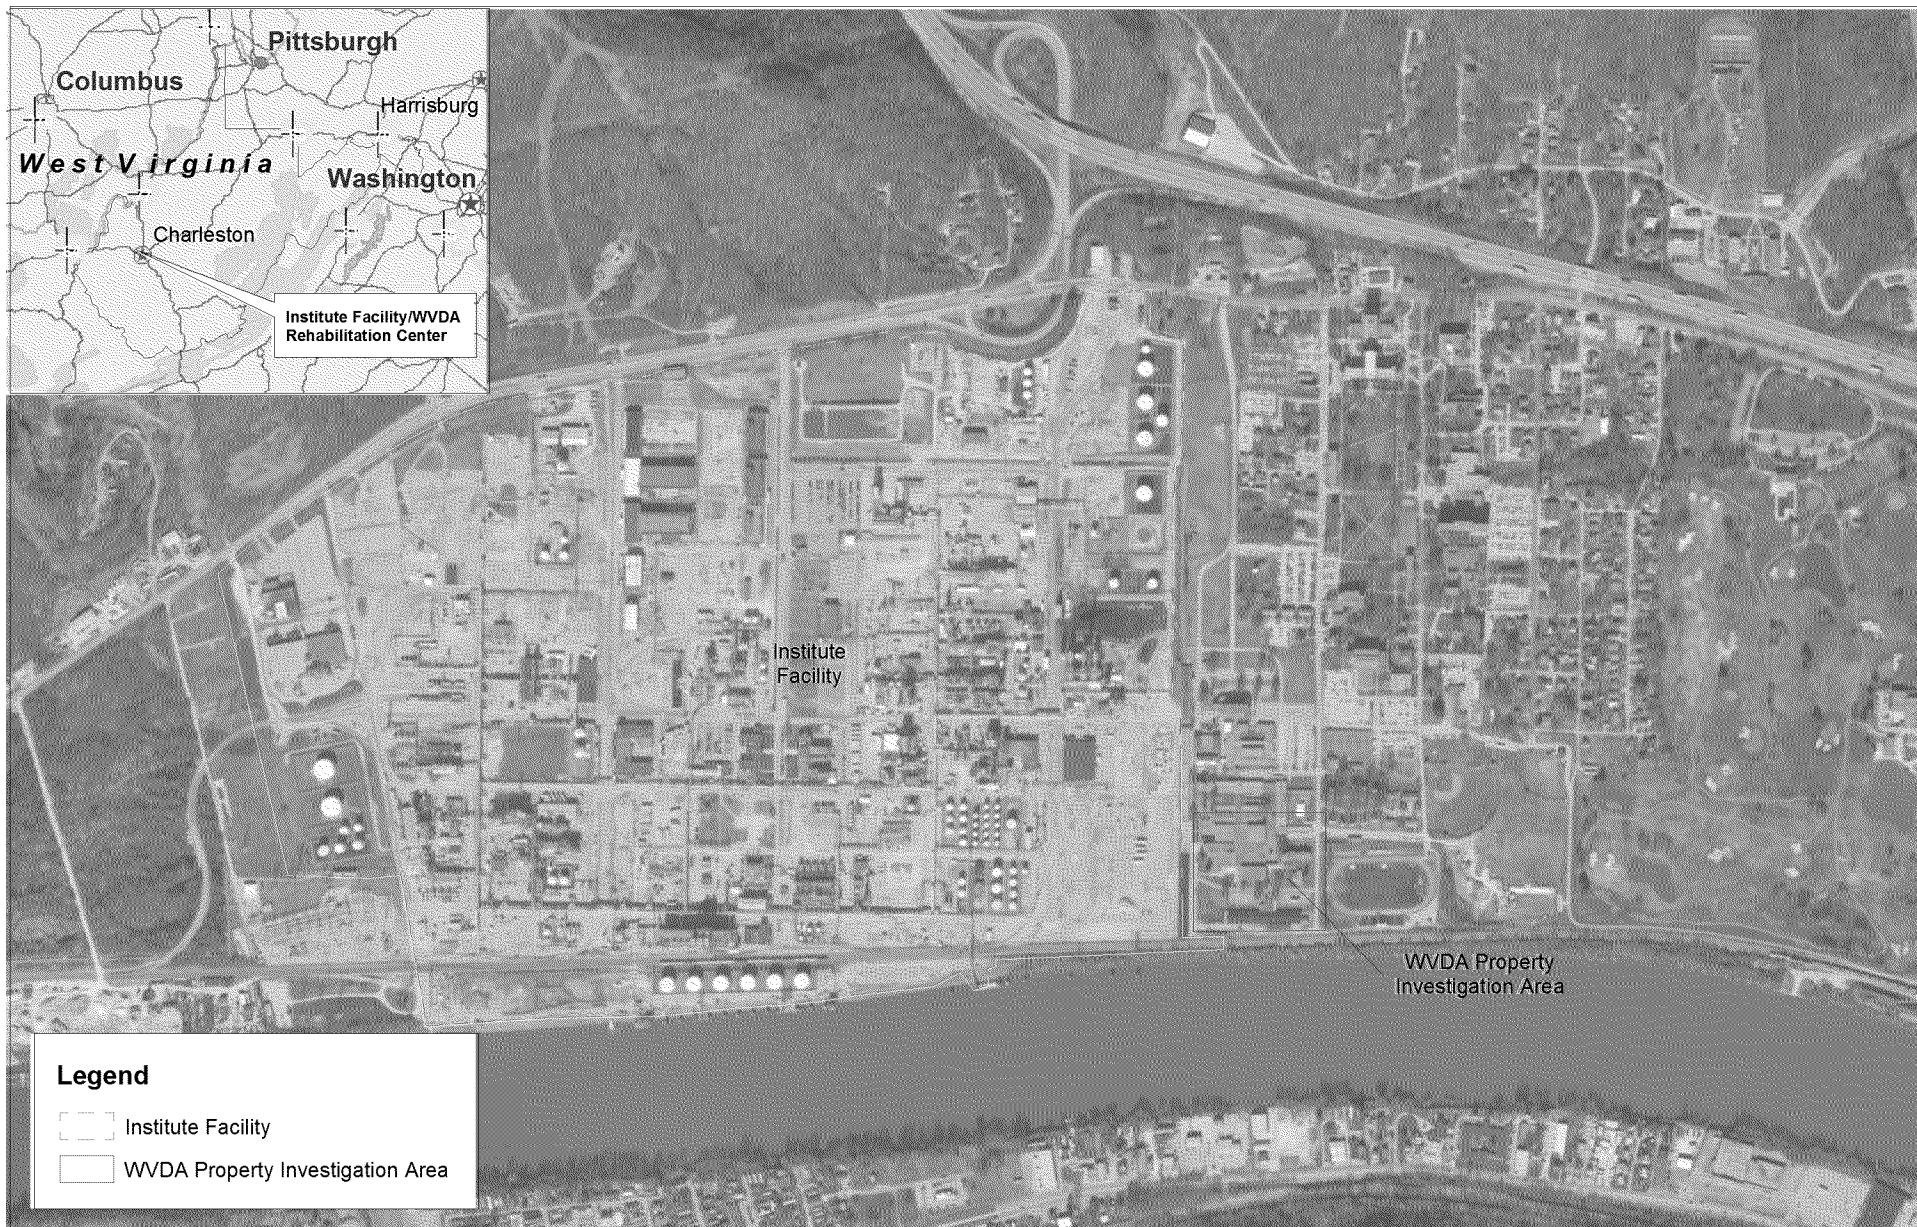
FIGURE 1
 Site Map
 East Property Boundary Investigation
 Bayer CropScience Institute Facility
 Institute, West Virginia

Groundwater sampling locations on the WVSU property were selected based on the following criteria: location (downgradient or sidegradient) relative to Institute wells TW-65A/B and VW-03A/B, accessibility, utility clearance, and spatial distribution on the WVSU property. Four temporary monitoring wells were installed to obtain sufficient water level information to determine groundwater flow on the WVSU property. The investigation locations are shown on Figure 2.
